# Design, Fabrication and Performance Evaluation of a Potato Grader for Village Level Operations Prototype II

Marvin T. Valentin<sup>a</sup> and Elmar M. Villota<sup>b</sup>

Benguet State University, La Trinidad Benguet, Philippines<sup>a</sup>

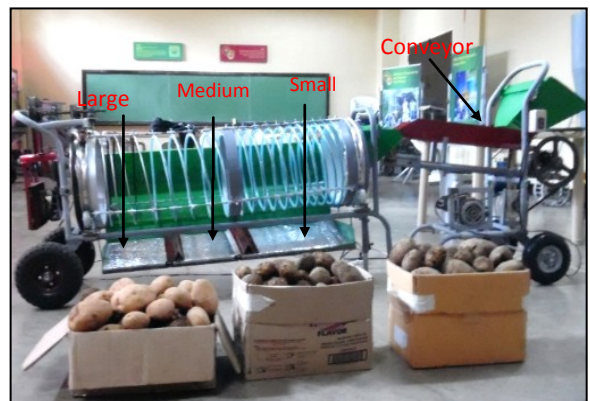
Figure 5. Fabricated potato grader

The region for the small sized tubers had the longest length as shown in Figure 5. A very limited length of this region decreases the chance of tubers to interact with the gaps since this contains all the samples during the start of the operation.

The collection tray provided under the grading unit was made of Galvanized Iron sheet (gauge # 16). It was covered with soft materials to prevent tubers from bruising when dropped from the grading unit. It had three regions for the sizes of the graded tubers, the regions for the small, medium and large sized tubers.

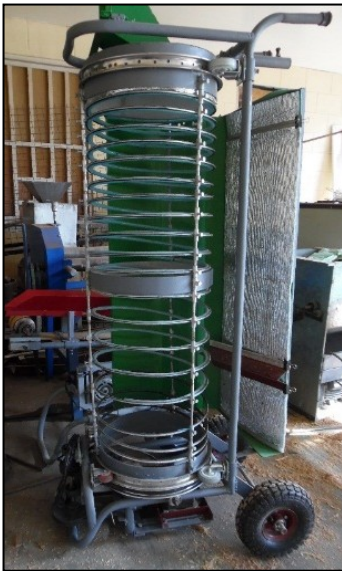
Figure 6. Potato grader in upright position

The frame was also designed to place the grader into a vertical position for convenience in storage after the harvest season as shown in Figure 6.

Galvanized Iron pipe (20.0 mm) was made for the framing of the grader and the conveyor. Installed at the end of the frame was a pair of rubber wheels (25.0 cm) which enable transportability of the device. Extended length of the frame was bent and served as handle and at the same time support post when the grader is in horizontal position during operation. Between the handle is adjustable metal tube to incline the grading unit.

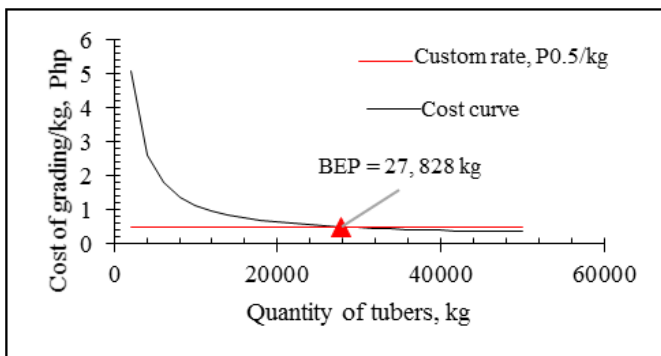
Figure 8. Break-even curve of the potato grader

cost of P72.25/hr. Assumptions include: interest, 10%, tax, insurance and shelter, 3%, repair and maintenance, 15%, operation per day, 8 hr, annual use, 600hr and custom rate P0.5/kg. The grader had a break-even point of 28ton/year. Shown in Figure 8 is the cost curve emphasizing the break-even point of the potato grader. If available quantity of tubers is greater than the break-even quantity, the use of the grader will result to profit. Otherwise, the device is expensive to use when available quantity is less than the break-even quantity.

The total cost of the potato grader was P 37, 000.00 with an estimated life span of 5 years. It had an annual fixed cost of P 9906.75 and variable operating
